# Building Assessment Inspection

## Property Condition Report

**Project Site:** *Street Address*  
**Fort Worth, Texas**  
**Project #**

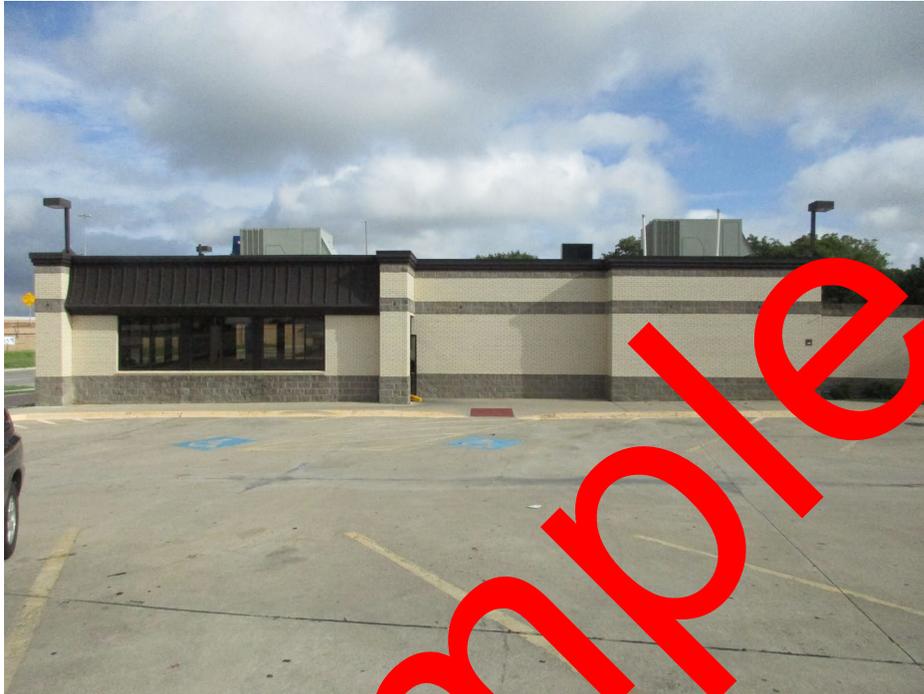
8. There are two (2) handicap parking spaces located on the south side of the building adjacent to the entry walk/landing. A striped loading zone aisle is located between them. The size, striping, and logo at the handicap parking space and loading zone appear to be in compliance with ADA regulations. The real issue is that there are no pole or building mounted signs identifying the handicap parking spaces. These signs must be installed to be in full compliance with ADA regulations.

**PHOTO #1** – Typical view of building, parking lot, and handicap parking spaces.

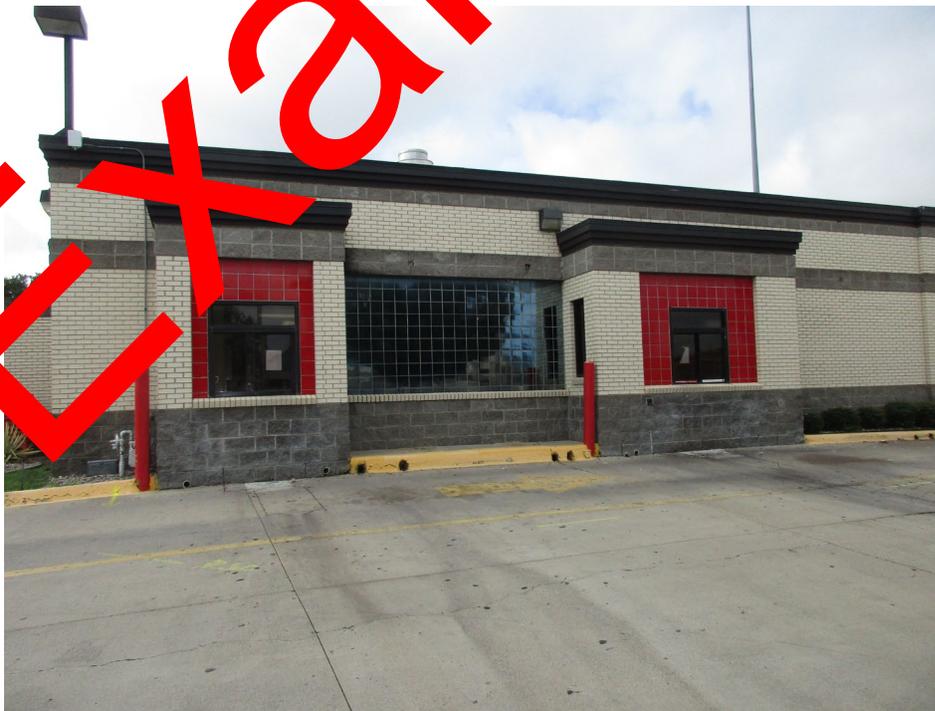
4. There are steel bollards located at the outside corner of the drive-thru extensions.
5. The parking lot, drive areas, and drive-thru lane appear to have very little slope for water run-off. Even though there was water stains in the main parking lot on the south side there was no ponding. At the time of the site visit the only signs of water ponding due to poor drainage was in the northeast corner near the dumpster enclosure.

**PHOTO #2** – View of drive-thru window bump outs, bollards, lights, and wall finish.

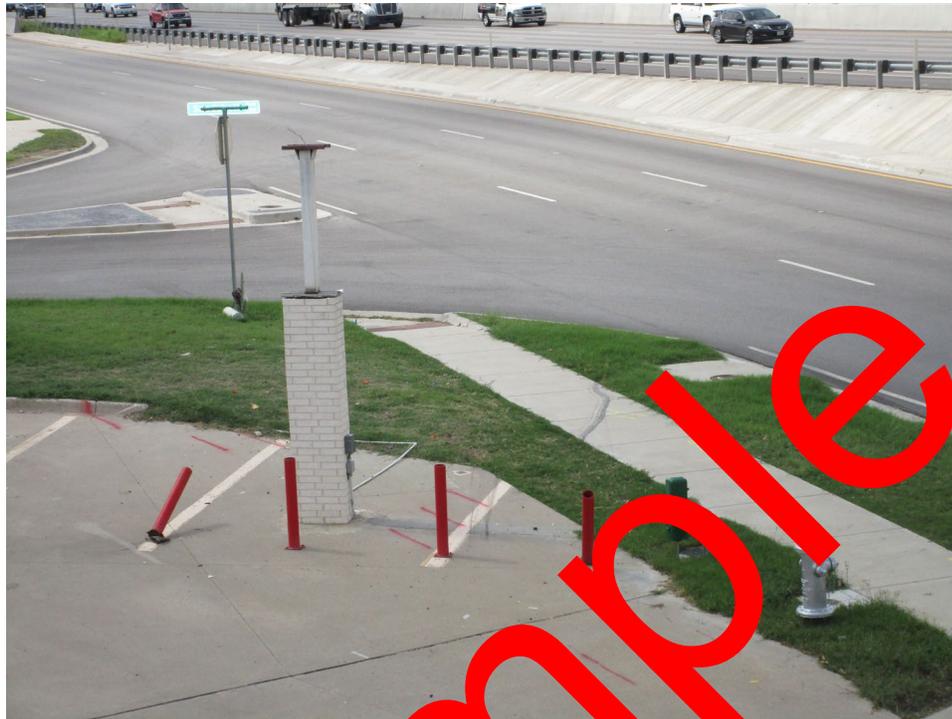
**PHOTO #3** – View of sign pole for previous tenant sign, bollards and fire hydrant.

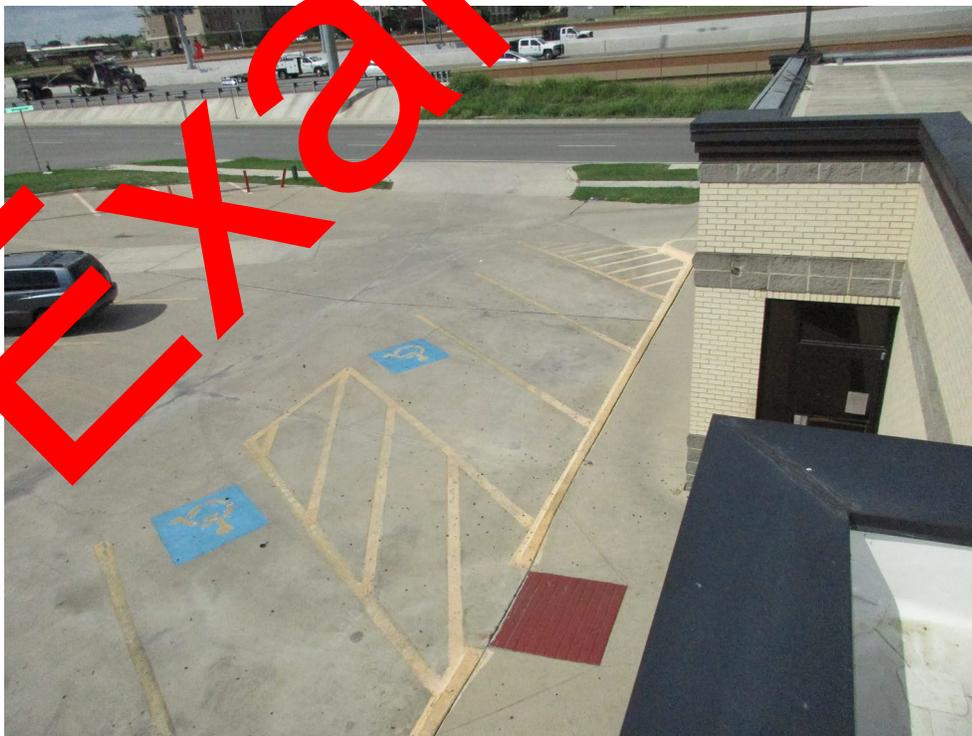
1. The main drive approach from the frontage road for Interstate 35W is concrete and appears to be in fair condition.
2. The parking lot is entirely concrete with concrete curbs. There are some signs of patching in the parking lot, but it appears to be where a landscape island was removed. There are typical signs of spotting, water drainage stains, and some minor cracking. Overall the concrete paving and curbs appear to be in good to fair condition. Although the parking striping is faded, it is still readable.
3. The drive-thru lane is concrete paving with striping separating the drive-thru from a bypass lane.

7. The handicap curb ramp is located in the south side of the building, at the main entry door. It is located at the handicap parking loading zone area and appears to have the proper maneuvering area at the top landing. It is concrete and appears to be in good condition with proper slope.

**PHOTO #4** – View of main drive approach, south parking lot, handicap parking spaces, and handicap ramp.

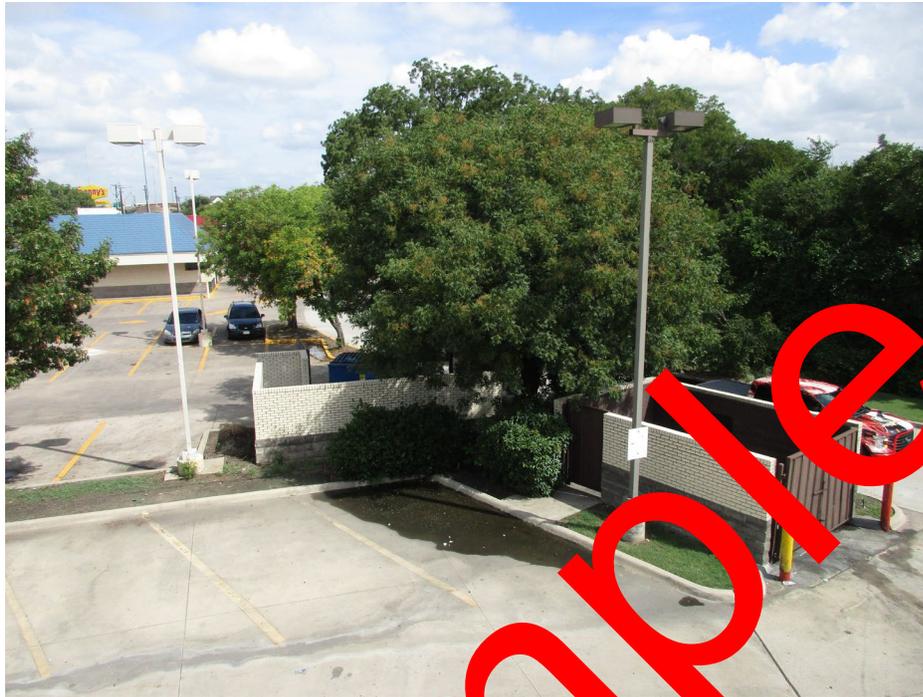
6. There is a dumpster enclosure located at the northeast corner of the property. The enclosure is concrete masonry structure with brick and CMU veneer to match the building. The enclosure has a pair of solid metal gates. There are steel bollards protecting the outside edges of the enclosure.

**PHOTO #5** – View of dumpster enclosure and pooling water in north parking lot.

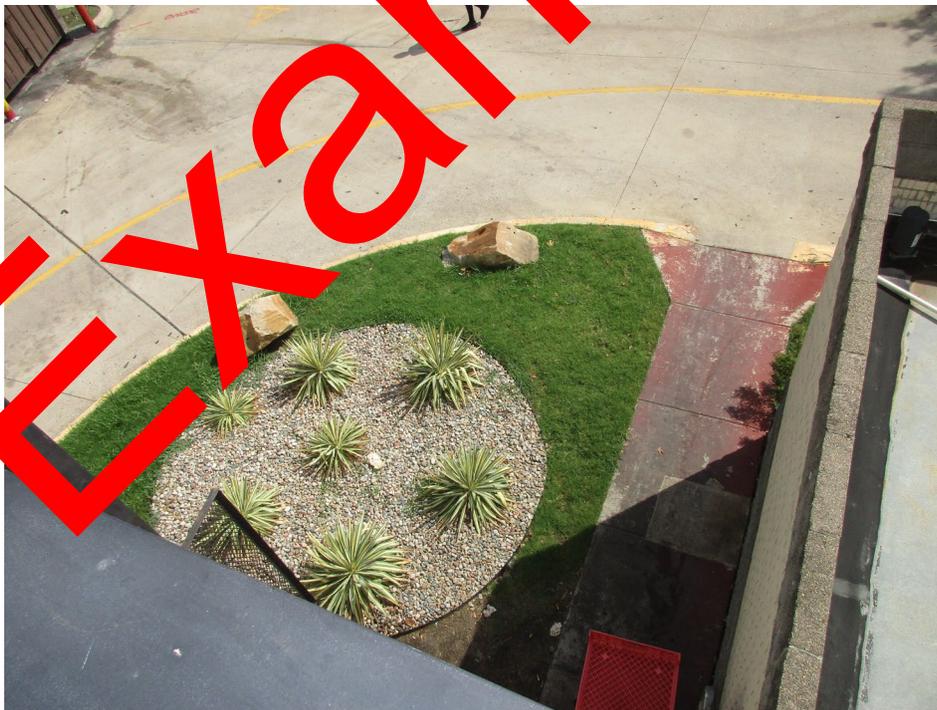
**PHOTO #6** – View of drive-thru lane, landscaping, and walk.

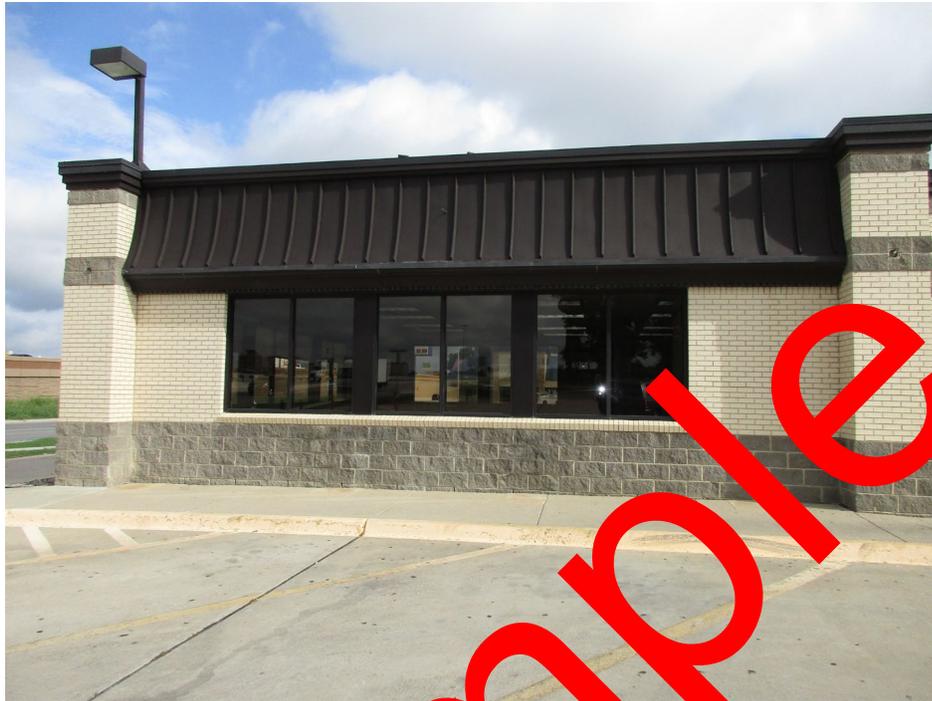
1. The building is basically a rectangular shaped building with pilaster bump outs at each corner of the dining area, two drive-thru service window bump outs on the north side, toilet room bump out on the south, and a cooler/freezer bump out on the east. The parapets for the main building are at the same elevation with no vertical extensions. The parapets for the two drive thru service windows are 39" below to main building parapet. The parapet around the cooler/freezer is 55" below the main building parapet. The entire exterior wall finish is masonry. The lower portion of the wall is 4 course of 8" split face CMU and the majority of the remainder of the wall finish is smooth modular face brick. There is a two course accent band of the 8" split face CMU at the top of the windows and another single accent band of 8" split face CMU just below the cornice. The cornice consist of three rows of stepped wood trim with a metal cap. Above the windows in the dining area there is a curved metal simulated "mansard" roof. The exterior masonry wall finishes, cornice, and metal simulated "mansard" roof appear to be relatively good condition.

**PHOTO #7** – Typical view of dining room windows, “mansard” roof, and wall finish.

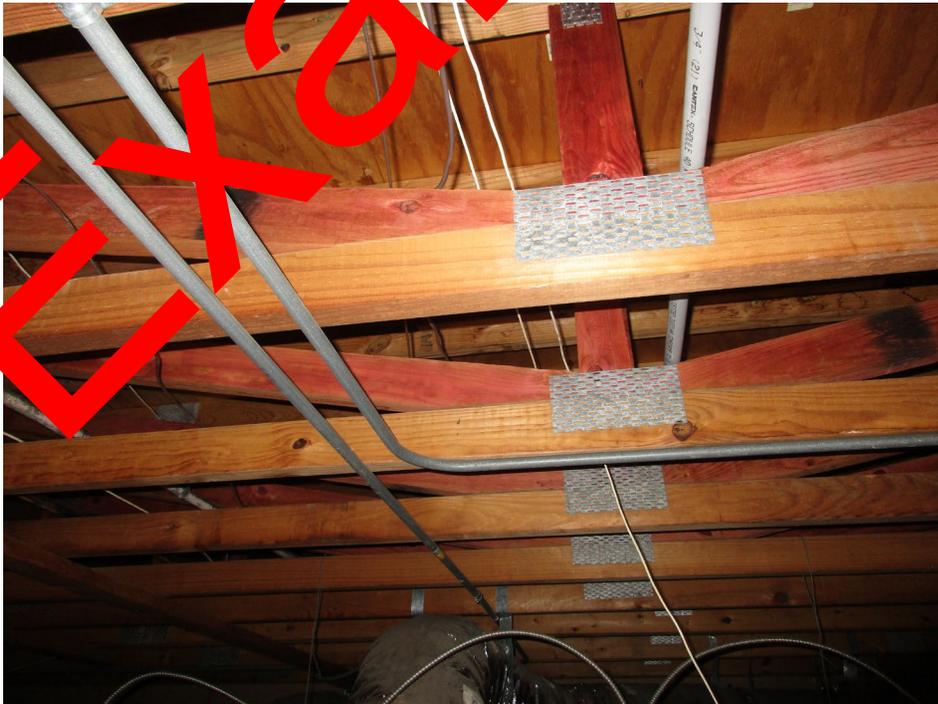
2. The building appears to be wood framed construction with open web wood roof joists and plywood deck. There was no insulation above the ceiling therefore it is assumed that the insulation is above the roof deck. During the site visit there was no way to identify the exact thickness of roof insulation.

**PHOTO #8** – Typical view of wood roof joist and deck.

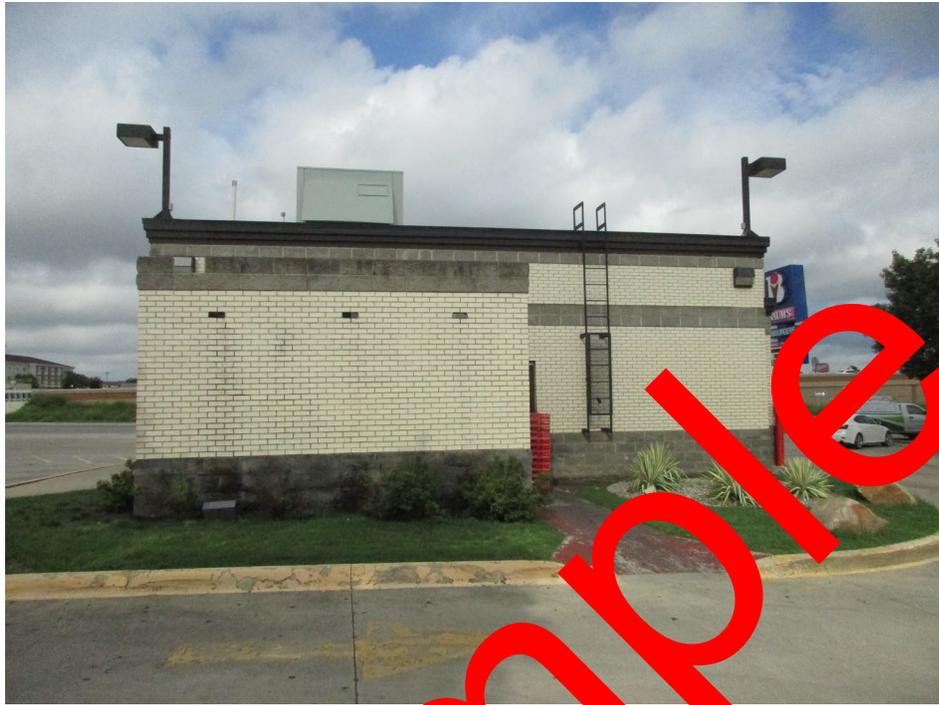
3. The cooler/freezer portion is a typical exterior rate assembly with load bearing roof supports. The entire unit is skinned with a single wythe of masonry that matches the remainder of the building. The roof is sloped to the east with three (3) thru-wall scuppers. There is a single block missing in the southeast corner of the parapet. This missing block should be replaced.

4. Roof access is provide by a wall mounted steel ladder with a protective expanded metal cage located near the service door.
5. The main building has a single membrane type roof (TPO) and parapet flashing system. The roof slopes to the north. There are three (3) roof drains and three (3) overflow drains located along the north parapet wall. The roofing membrane and parapet flashing appear to be in good condition.

**PHOTO #9** – View of Cooler/Freezer portion, drive-thru lane, and access ladder.

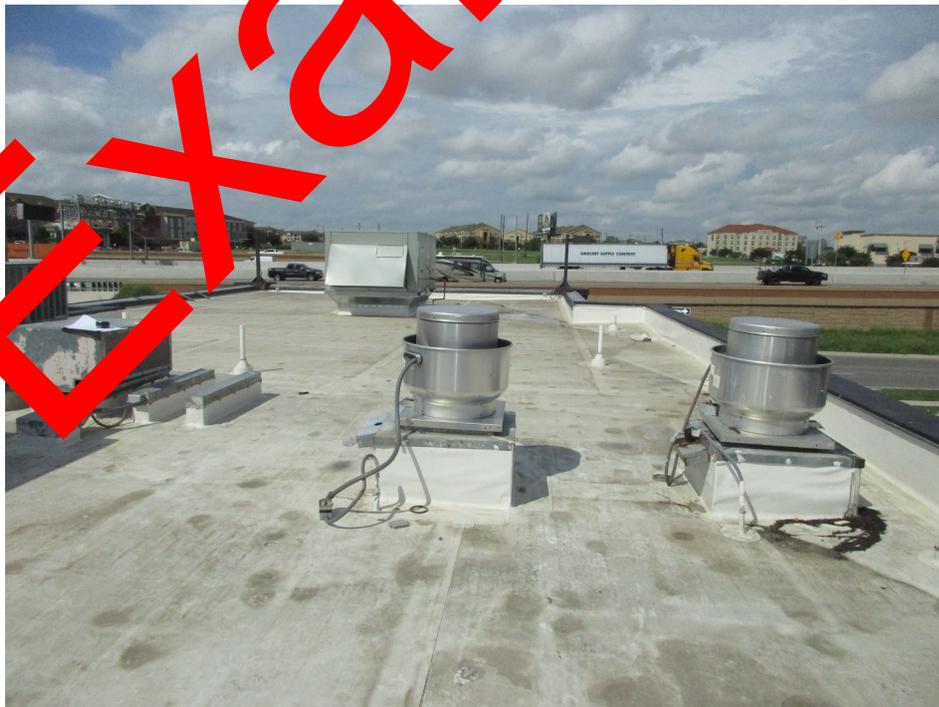
**PHOTO #10** – View of roofing and equipment.

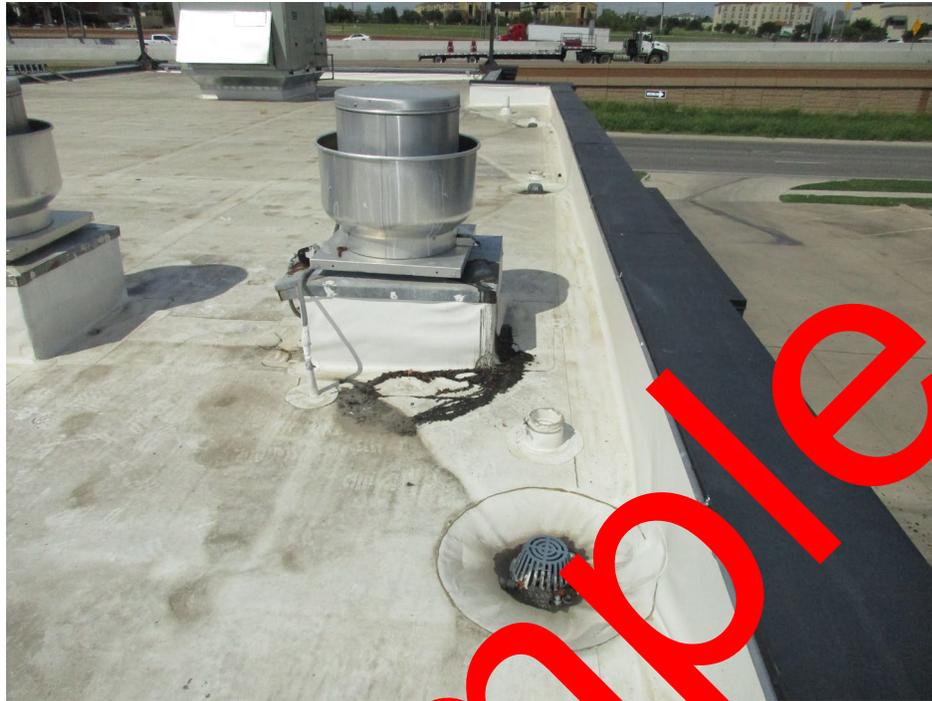
**PHOTO #11** – View of roofing, equipment, and roof drains.

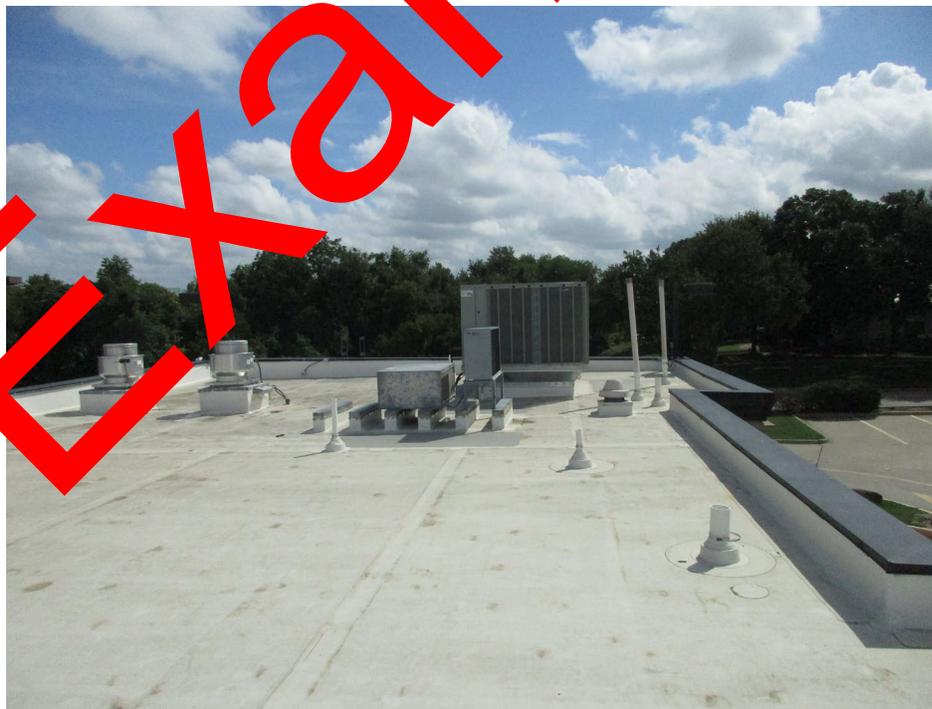
**PHOTO #12** – View of roofing and equipment.

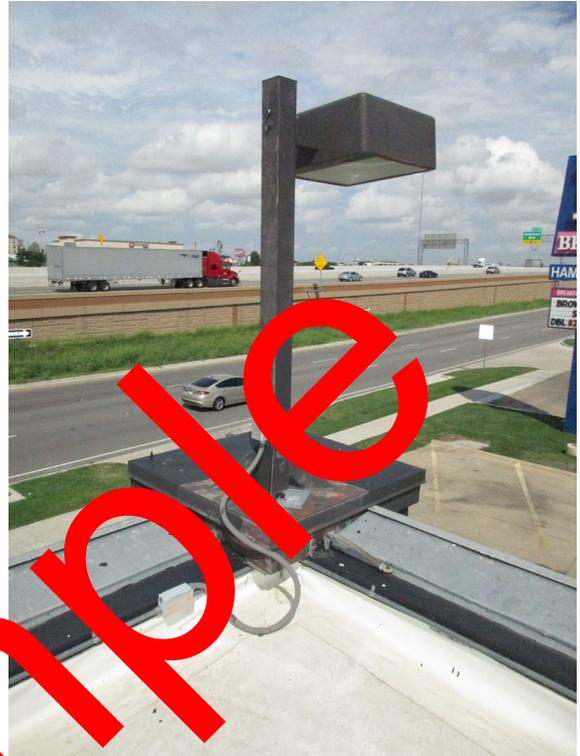
10. The site has a total of three (3) dual fixture pole mounted lights. One on the south, east, and north sides of the site. There is also, a single fixture pole mounted light mounted to the top of the parapet wall at each outside corner of the building for a total of four (4) fixtures.

**PHOTO #13** – Typical view of parapet mounted light fixtures.

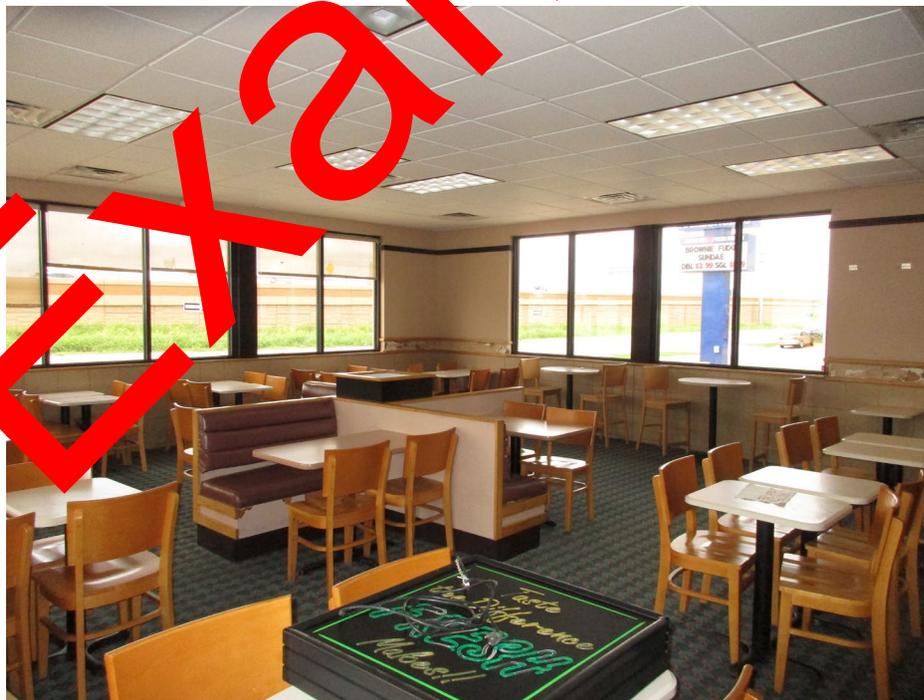
1. The serving area has tile flooring with tile base in the serving line area and carpet with tile base in the dining portion. The walls have a tile wainscot, 8" chair rail with painted gypsum board on the upper portion of the wall. The ceiling is a 2 x 2 suspended tile. In the serving area the previous staging railing system has been removed leaving protruding portions of the remaining rails. The dining area of the building appears to be in good to fair condition.

**PHOTO #14** – Typical view of dining Area.

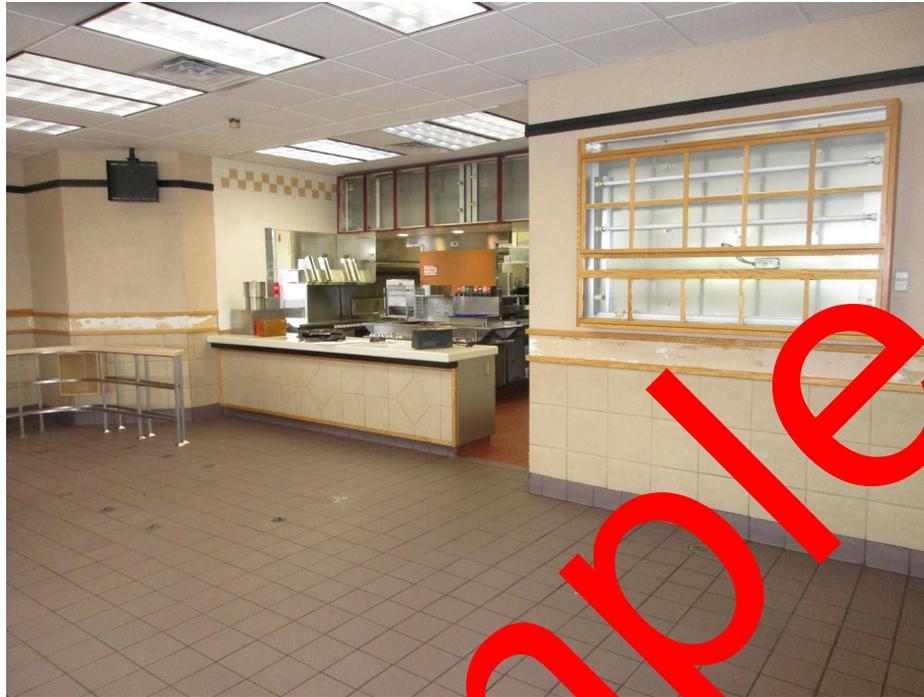
5. The serving area and west drive-thru window area have tile flooring with a tile base. The walls are full height tile. The ceiling in the serving area is 2 x 4 suspended ceiling with lay-in light fixtures and ceramic tile covered furr-down with recessed light fixtures. The ceiling in the west drive-thru is 2 x 4 suspended with lay-in light fixtures.
6. The back of house area includes cooking area, dishwashing area, office, break room, storage, and a second drive-thru window area. All rooms have tile flooring with a tile base. The walls are gypsum board with a full height FRP panel covering. The ceilings are a suspended system with lay-in light fixtures. There are signs of normal wear on the floor, ceiling, and wall surfaces. The suspended ceiling system is not a consistent grid layout and is in poor condition. Overall the back of house area is in fair condition.

**PHOTO #15** – Typical view of Serving area.

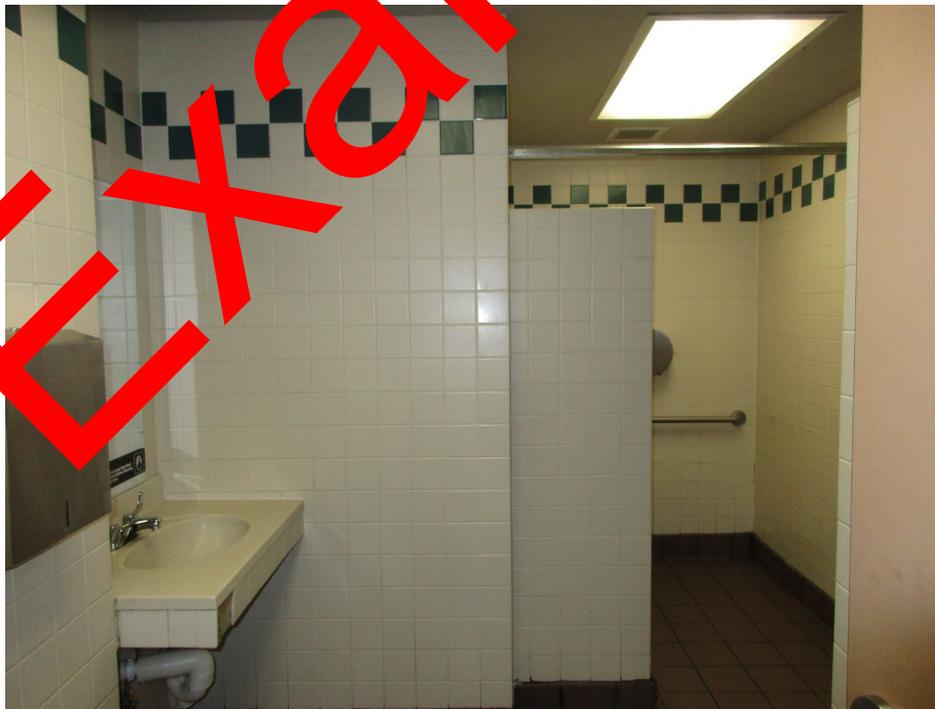
**PHOTO #16** – Typical view of Mens Toilet and fixtures.

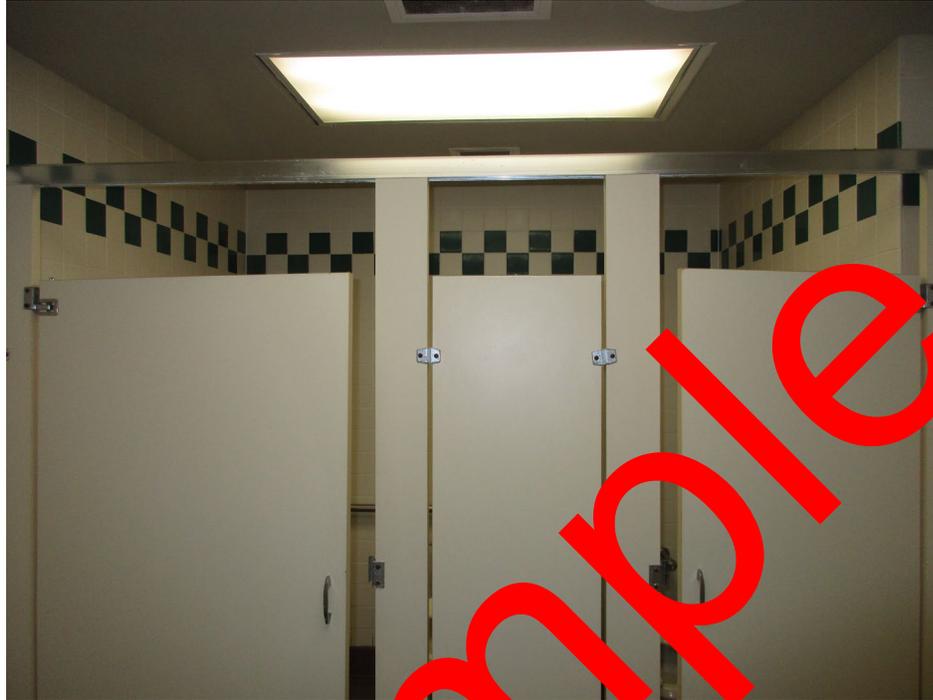
8. There are two toilets serving this building. The mens toilet has a one piece counter mounted lavatory, wall mounted urinal, and a floor mounted water closet along with accessories. The womens toilet has a one piece counter mounted lavatory and two floor water closets, along with accessories. The fixtures appear to be in fair to poor condition. The fixture appeared to be compliant with current ADA standards however there were issues with the floor area in the womens handicapped stall.

**PHOTO #17** – Typical view of Women's Toilet and toilet partitions.

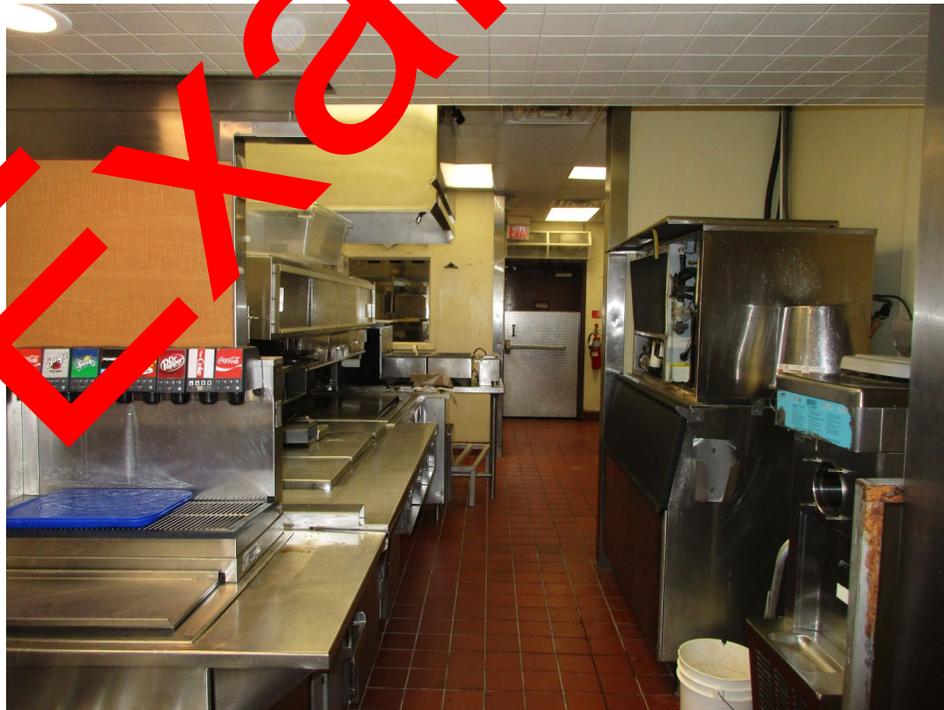
**PHOTO #18** – Typical view of cooking area.

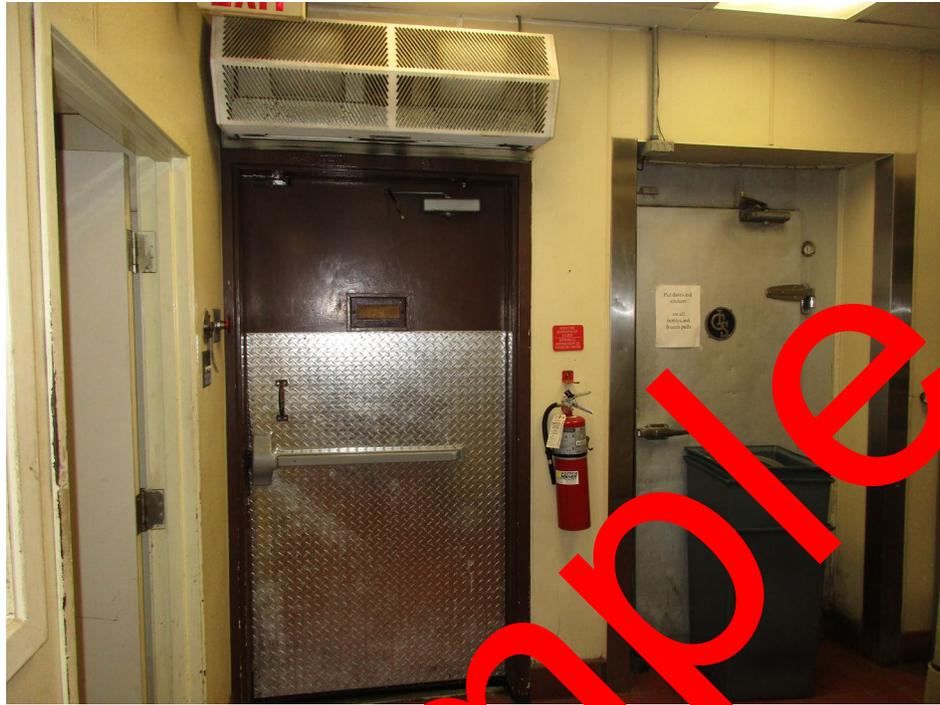
8. The north and south entry doors and all windows are a dark bronze aluminum store front type system. The rear service door is hollow metal door and frame system. There is damage to the main south entry door due to vandalism. Overall the aluminum doors and windows appeared to be in good to fair condition. The rear hollow metal door has signs of wear but was in fair condition.

**PHOTO #19** – View of service door and Cooler/Freezer entry.

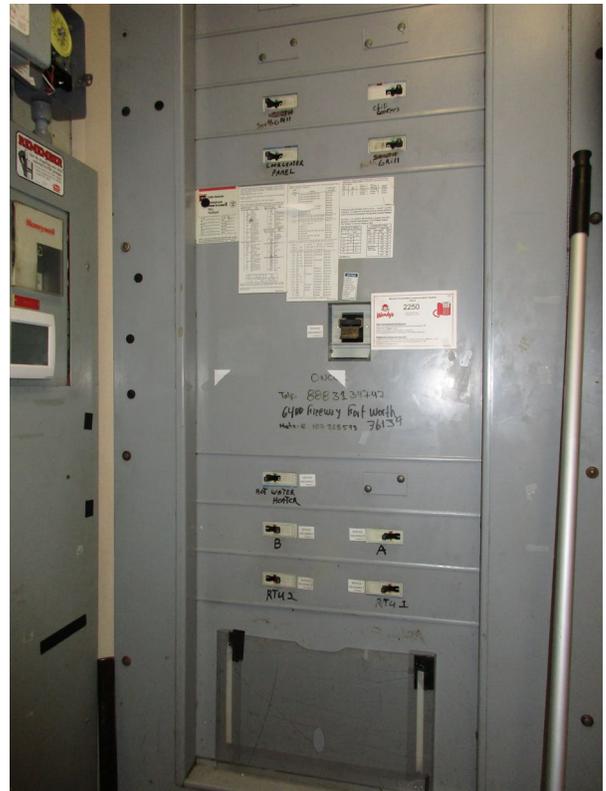
6. There is a main recessed disconnect panel and two (2) Cutler-Hammer recessed, 225 amp electrical distribution panels in the office area. The electrical panels appear to be in fair to poor condition.

**PHOTO #20** – View of main electrical panel and breakers.

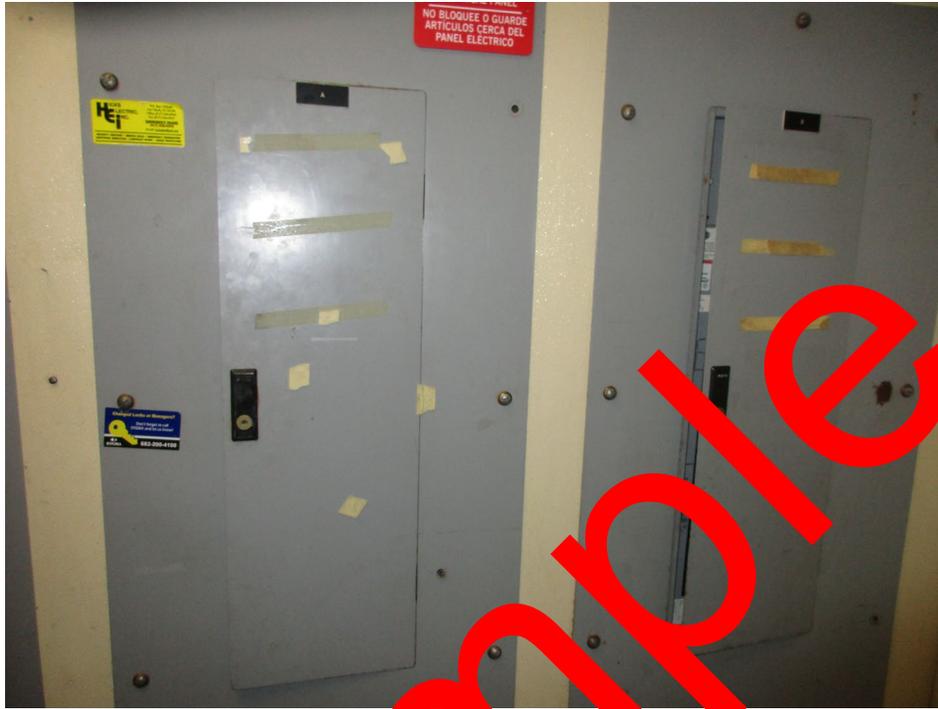
**PHOTO #21** – View of electrical distribution panels.

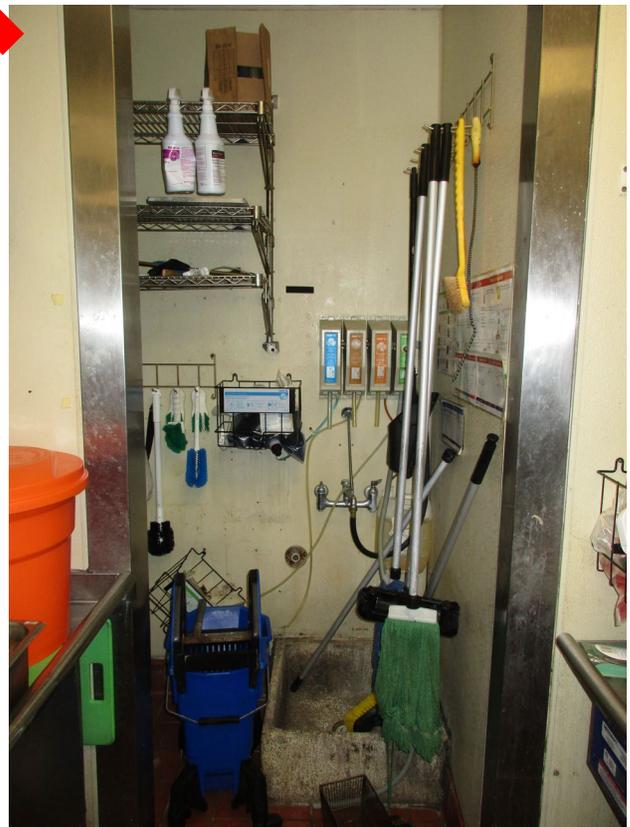
9. There is a mop sink located in the back of house adjacent to the dishwashing area. The area is wrapped with FRP wall paneling and stainless steel edge guards. The mop sink and accessories are in poor condition.

**PHOTO #22** – View of mop sink area.

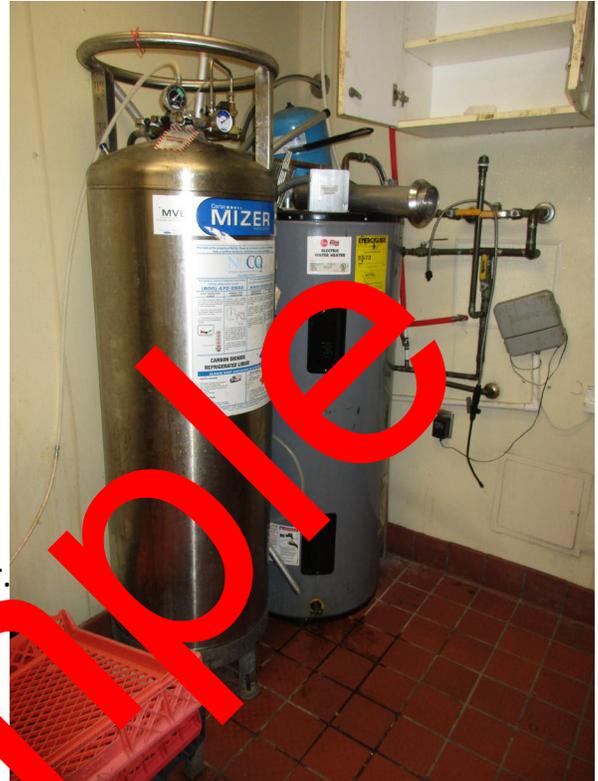
11. There is an 80 gallon electric water heater located in the back of house in the storage area. The unit is open to the rest of the back of house space and not in a separate room. The water heater appears to be in good condition.

**PHOTO #23** – View of electric water heater.

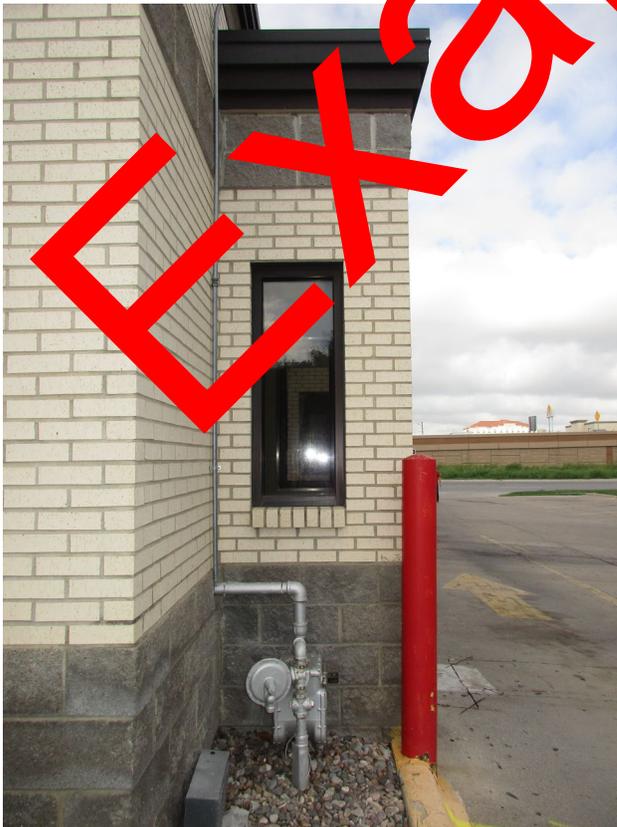
12. There is a gas meter located in the northeast corner of the building near the east drive-thru window.
13. There are three water meters located at the edge of the driveway on the west side of the building. During the time of the site visit only one was accessible, it was a 1 1/2" meter. There were no identification on the meter covers indicating what they served.

**PHOTO #24** – View of gas meter and drive-thru window area.
